TEST REPORT

Reduction of Bird – Window Strikes

SEEN glass elements

Tests in Flight Tunnel II
according to WIN-test procedure
at Biologische Station Hohenau-Ringelsdorf,
Austria

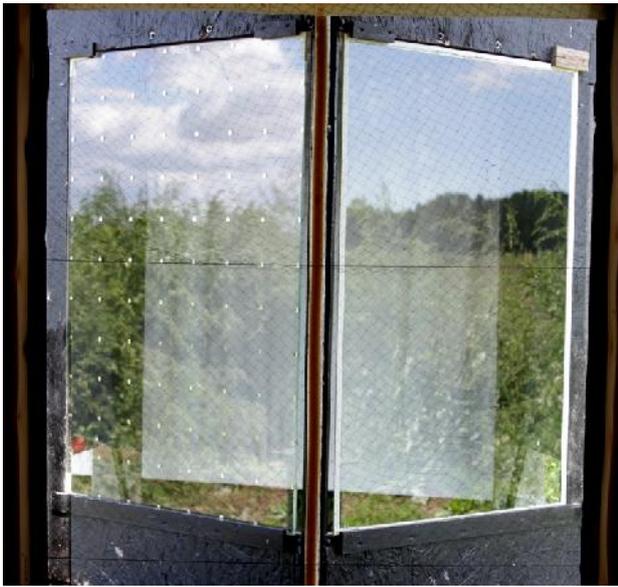
Figure 1: Test candidate “SEEN shiny” (left) and unmarked float glass reference (right) in the perspective of an approaching bird in the flight tunnel.

Reflective dots – “SEEN shiny”

Glass composition: 4mm low iron glass + 2 x 0.76mm PVB interlayer + 4mm low iron glass, SEEN glass elements applied between the foil layers.

Pattern: 9mm dots with a distance of 90mm from point centre to point centre, covered area 0,8%.

Material: dots (SEEN glass elements) are multi-layer elements with reflective aluminium coating on the front, colored black on the rear side (rear side can also be the same as front side). Due to the composition of the layers, they are having a 3D effect. The visual reflection of the reflective aluminium coating is 89% (measured in the laminated glass).

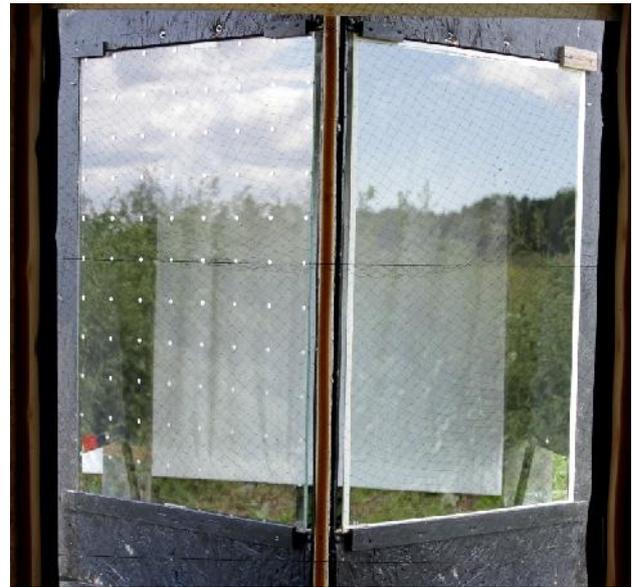
Figure 2: Test candidate “SEEN matt” to the left, float glass reference to the right.

Semi-reflective dots – “SEEN matt”

Glass composition: 4mm low iron glass + 2 x 0.76mm PVB interlayer + 4mm low iron glass, SEEN glass elements applied between the foil layers.

Pattern: 9mm dots with a distance of 90mm from point centre to point centre, covered area 0,8 %.

Material: Same material as reflective dots, but the visual reflection of the semi-reflective aluminium coating is 75% (measured in the laminated glass).

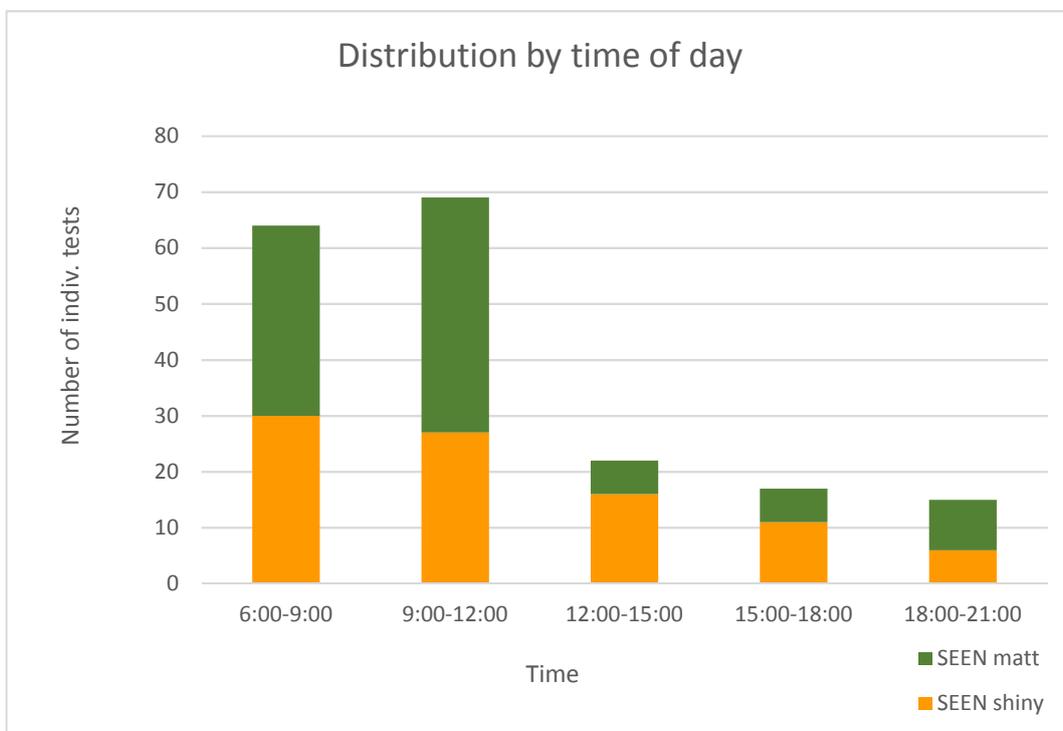
Figure 5: Distribution of valid tests by time of day. Orange: SEEN shiny, green: SEEN matt

Fig. 5 shows how the tests were distributed over the time of day. In relation to the number of birds caught at the bird banding station, with highest bird activity in the morning, 64 individual tests (34 %) were performed before 9:00 a.m., and 69 individual tests (37 %) between 9:00 and 12:00 p.m. All in all, 133 tests (71 %) were performed before noon, and 54 (29 %) in the afternoon until sunset.
